SUPERALLOY KNIFE EDGE SEAL REPAIR

GENERAL ELECTRIC COMPANY
CINCINNATI, OHIO 45215

MAY 1978

TECHNICAL REPORT AFML-TR-78-56
Final Report for period 1 March 1976 to 31 November 1977

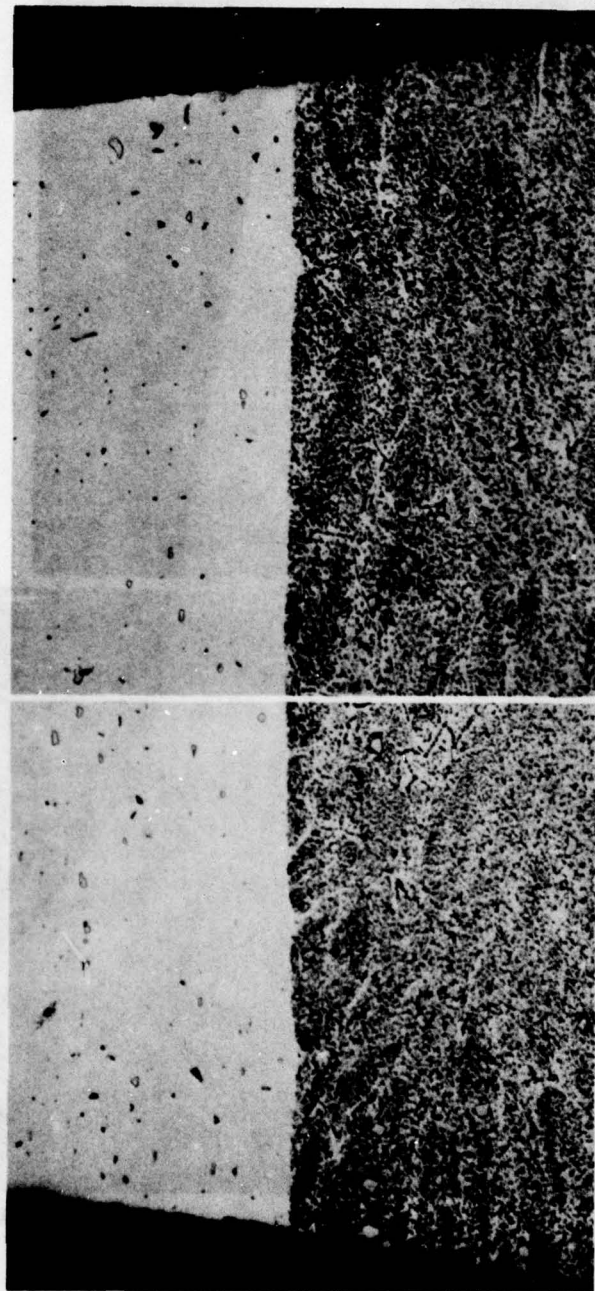
Figure 51. Bond Line of Center Tooth of Figure 50.

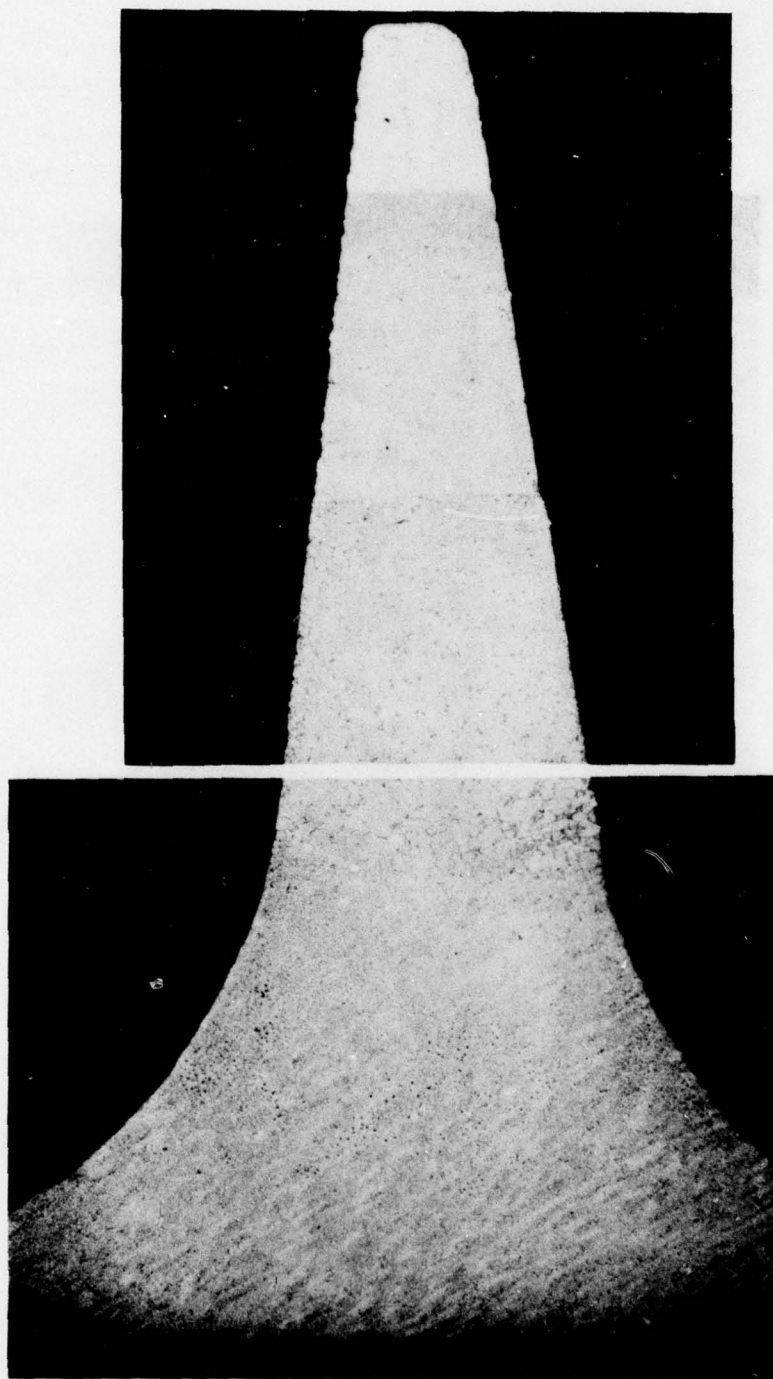
Figure 52. Cross Section of Center Tooth of Seal Ring #5 at Location X-2.

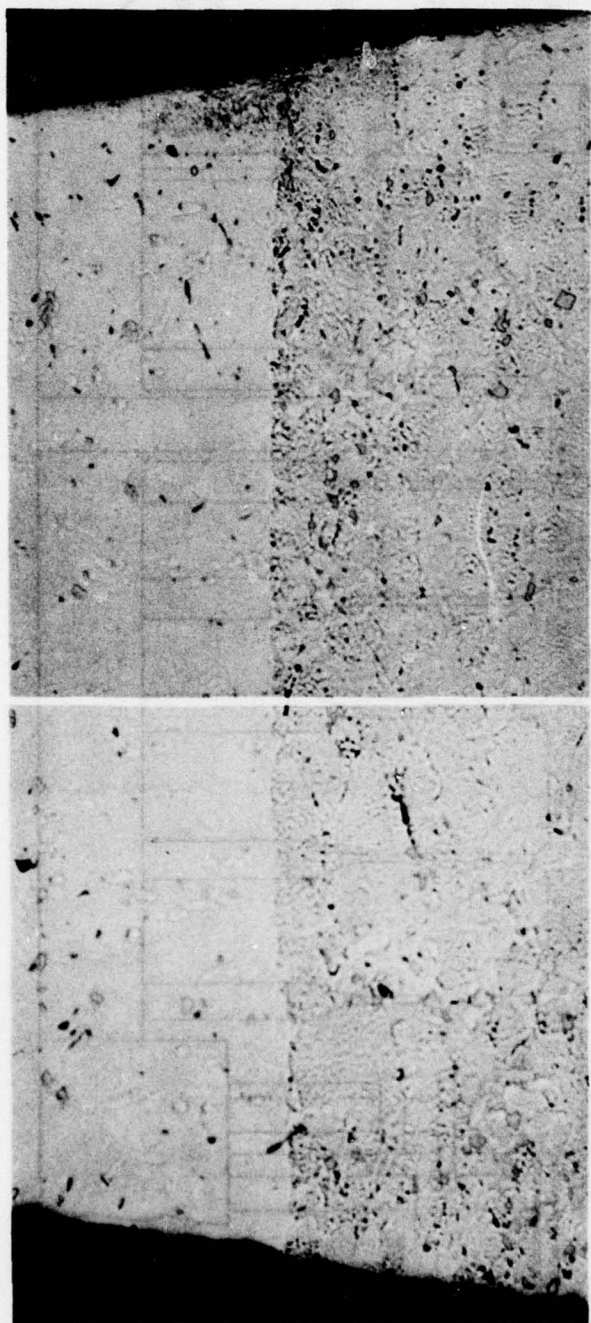
Figure 53. Bond Line of Center Tooth of Figure 52.

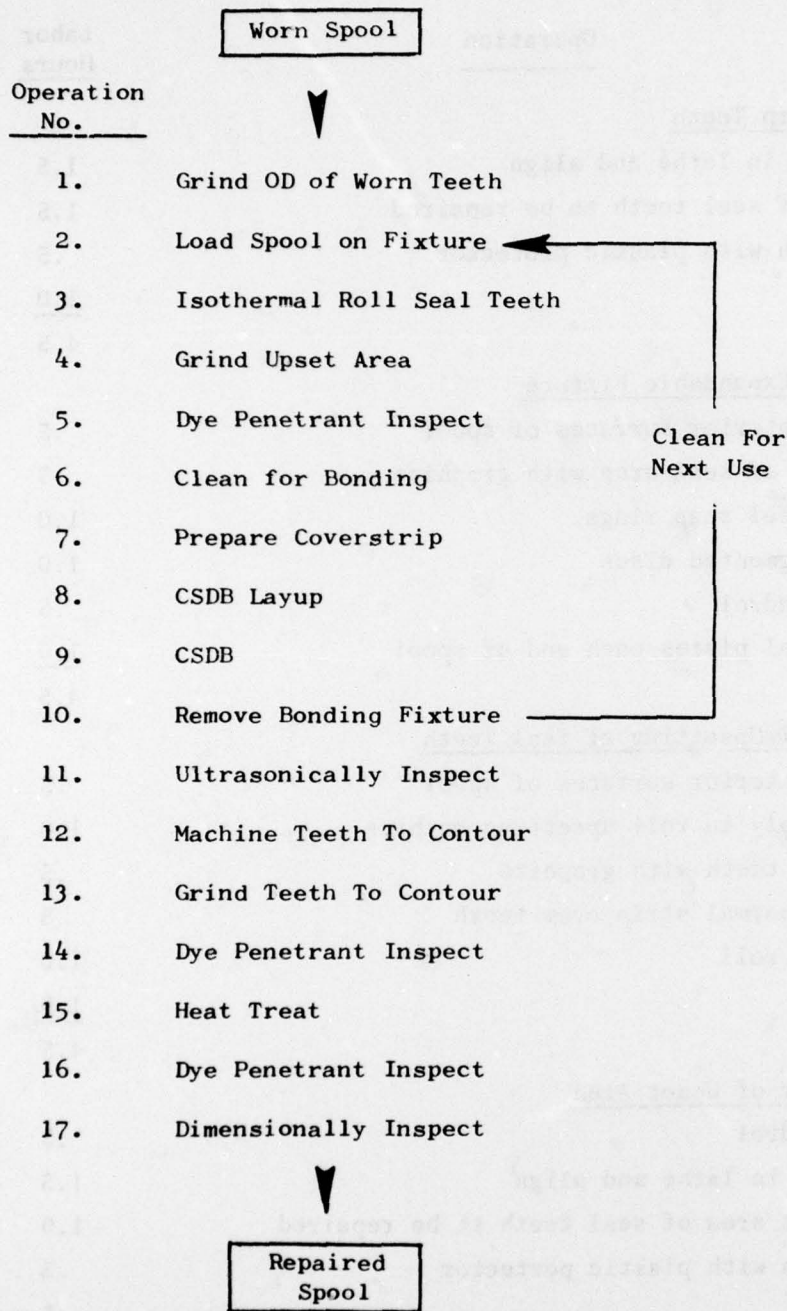
Figure 55. CSDB Processing Flow Chart

A flow chart describing the approach for the repair of worn seal teeth on the CRS is shown in Figure 55. The estimated costs expressed in labor hours are listed in Table XVI. They are estimated under the assumption that one stage of seal teeth is to be repaired. Costs are not included for the Inconel 718 cover strip and thermal strip, or blade split rings, which provide support for the cover foil. Costs are also not included for expendable items such as cover foil, foil strapping material, hydrogen and argon gases, etc. However, a conservative estimate would be \$500.
